6 PROCEEDINGS OF THE 1980 TRI-SERVICE
CONFERENCE ON CORROSION

5-7 NOVEMBER 1980
US AIR FORCE ACADEMY, COLORADO, Volume I.

CORROSION OF NAVAL SEA SYSTEMS
AN OVERVIEW

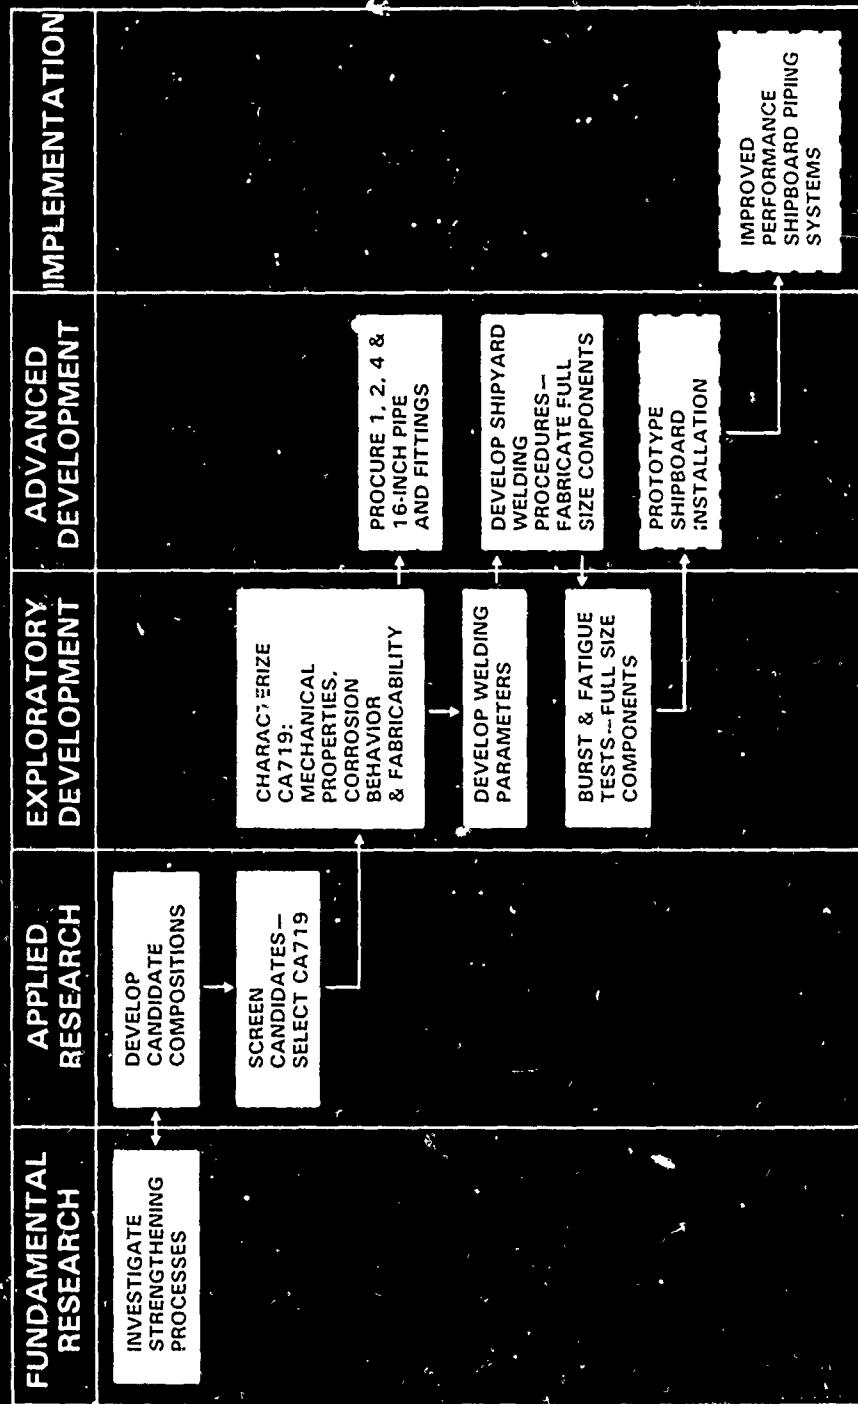
Figure (13)

DEVELOP HIGHER STRENGTH COPPER/NICKEL ALLOY FOR SHIPBOARD PIPING SYSTEMS

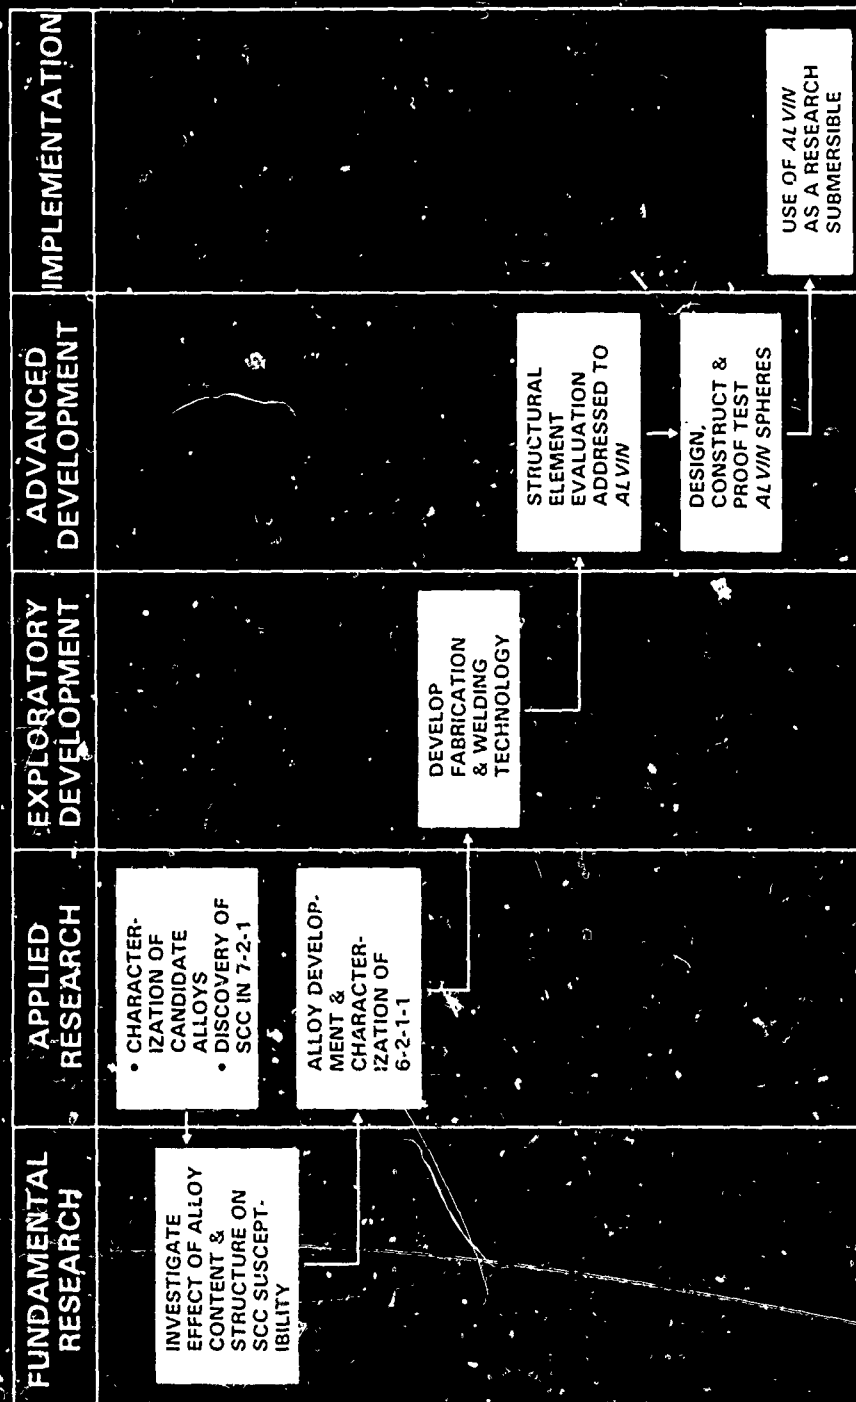
Figure (20)

DEVELOP HIGH STRENGTH/ WEIGHT TITANIUM ALLOYS FOR DEEP DEPTH SUBMERSIBLES

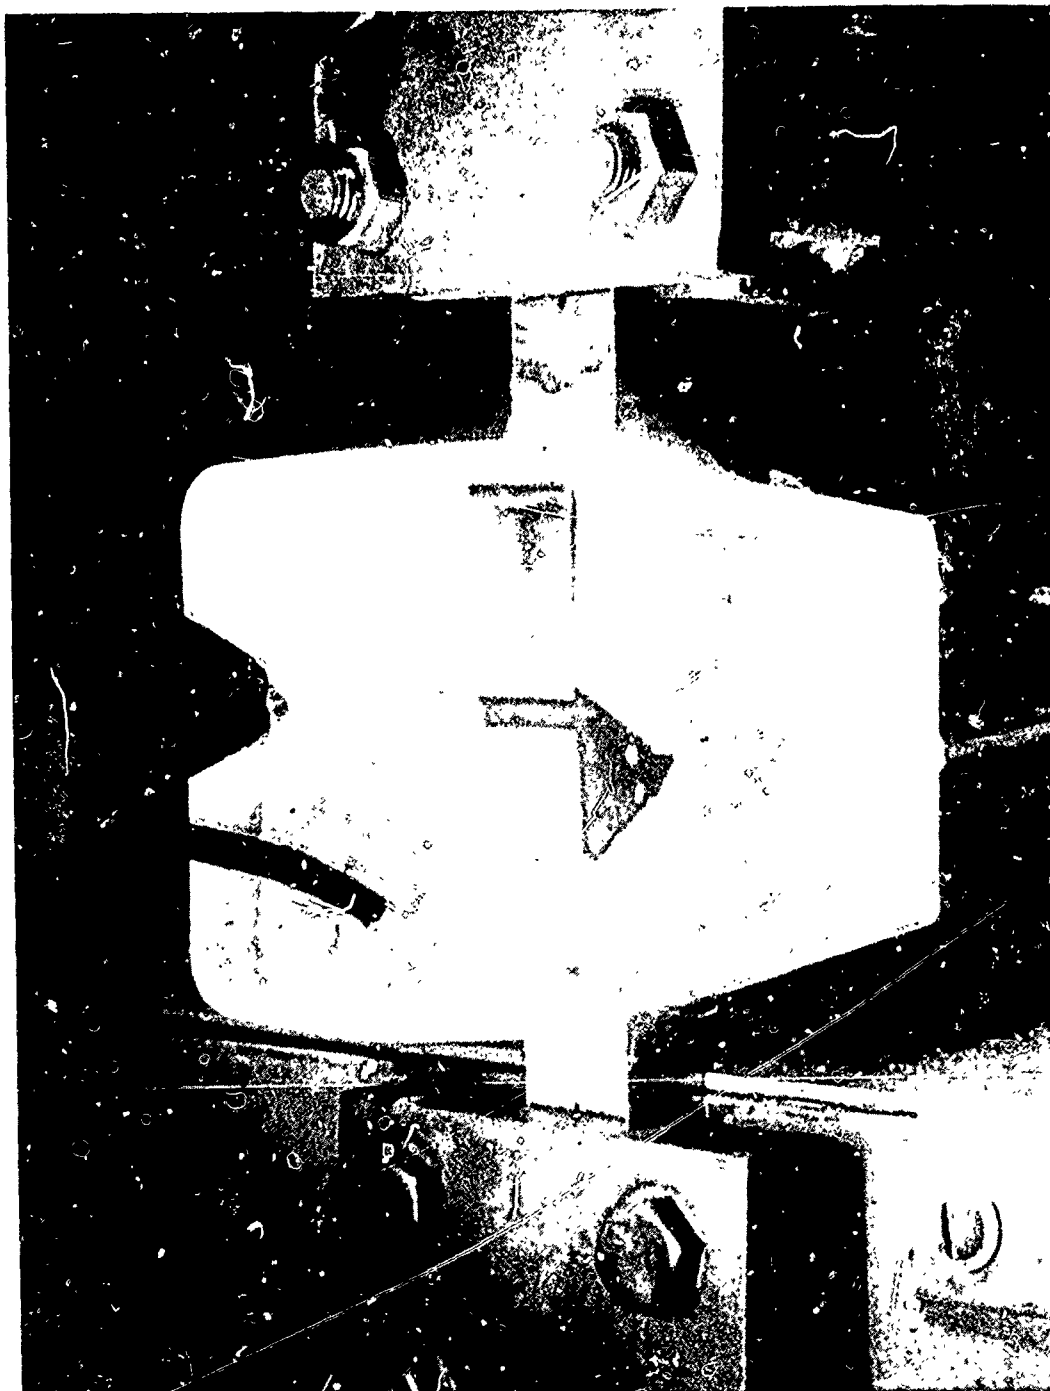
Figure (21)

Fracture Surface of A Cantilever Stress Corrosion Specimen

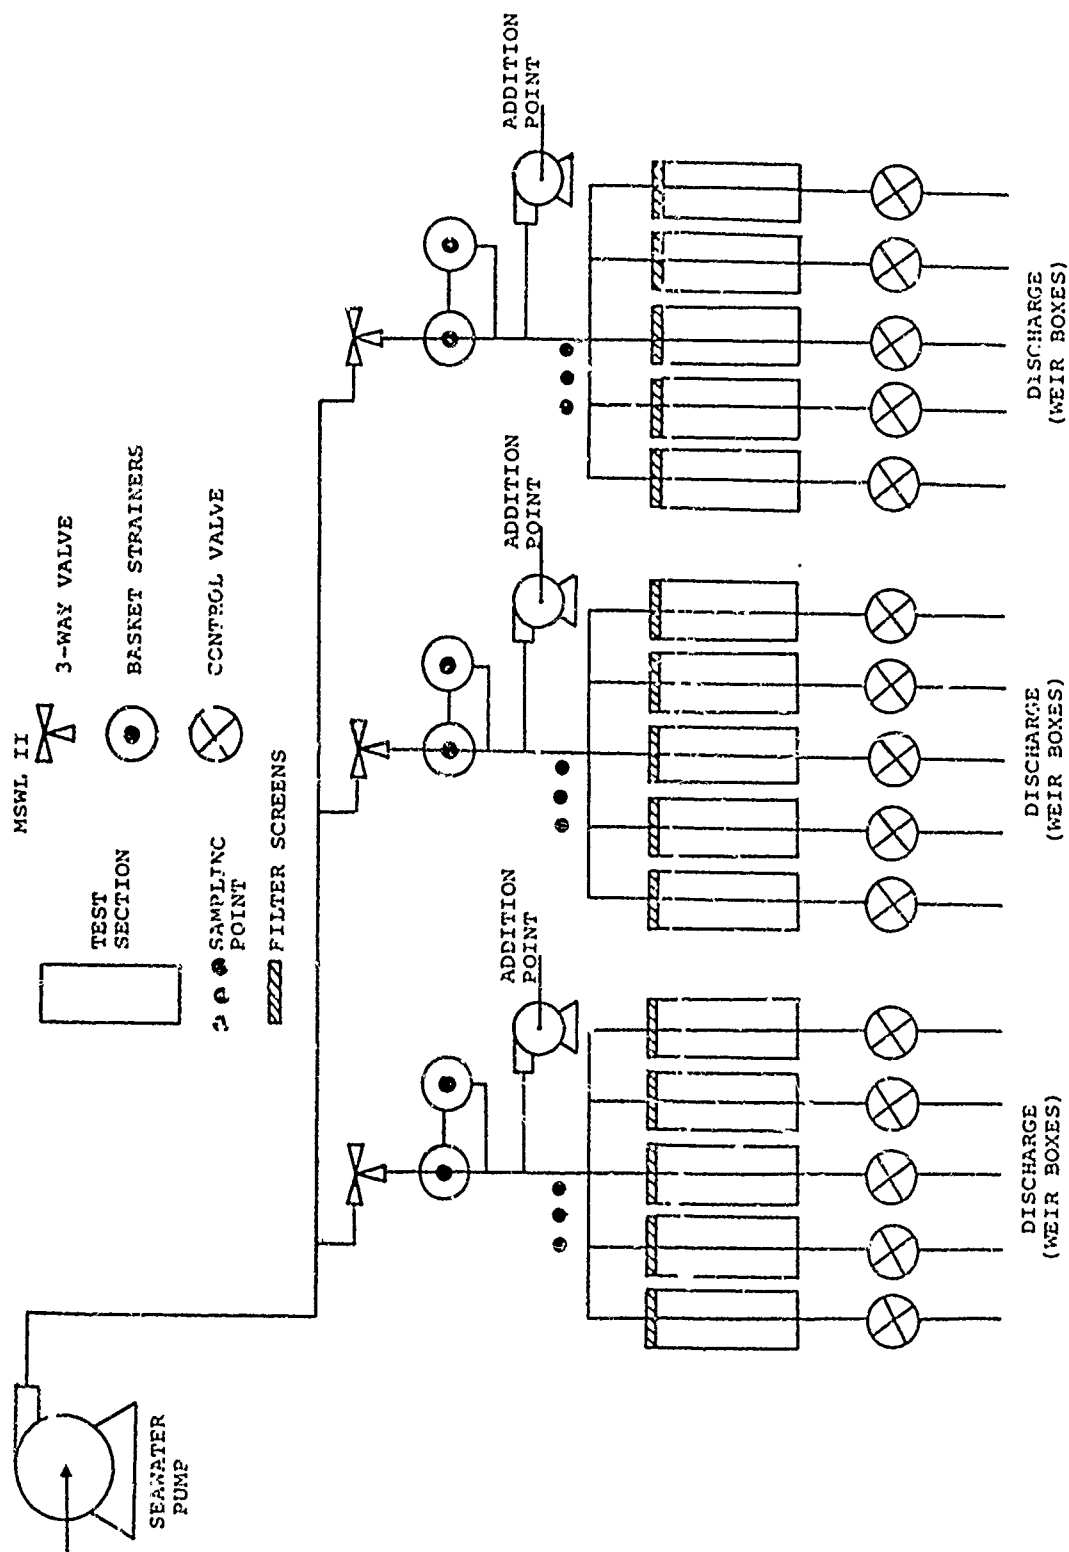
Figure 1 - Modified Seawater Test Loop

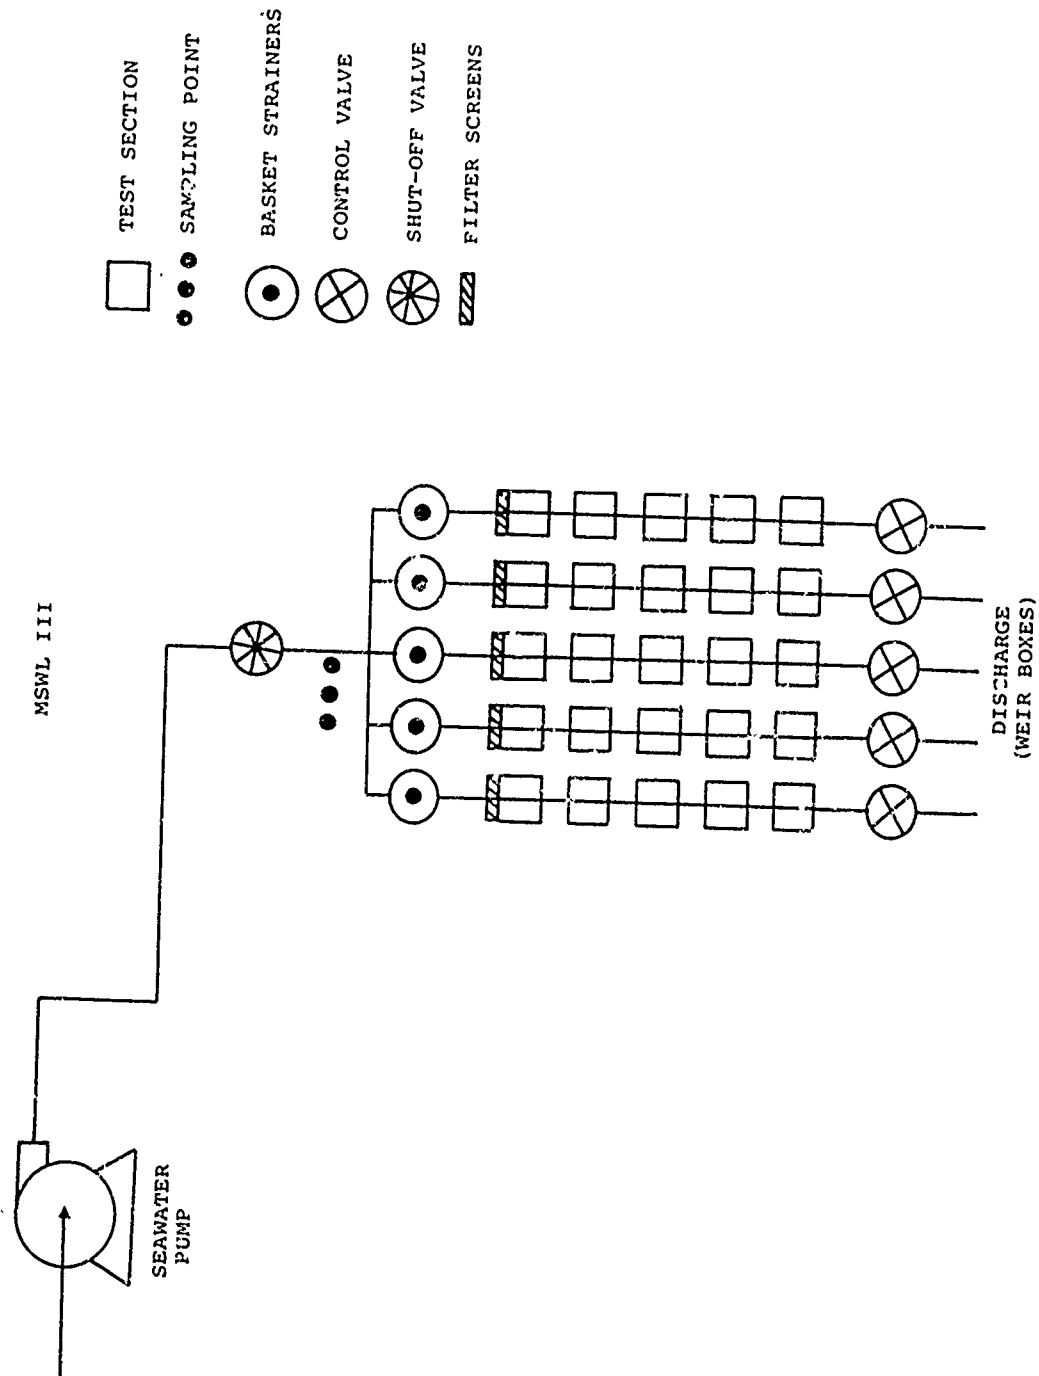
Figure 2 - Seawater Test Loop for Control Specimens

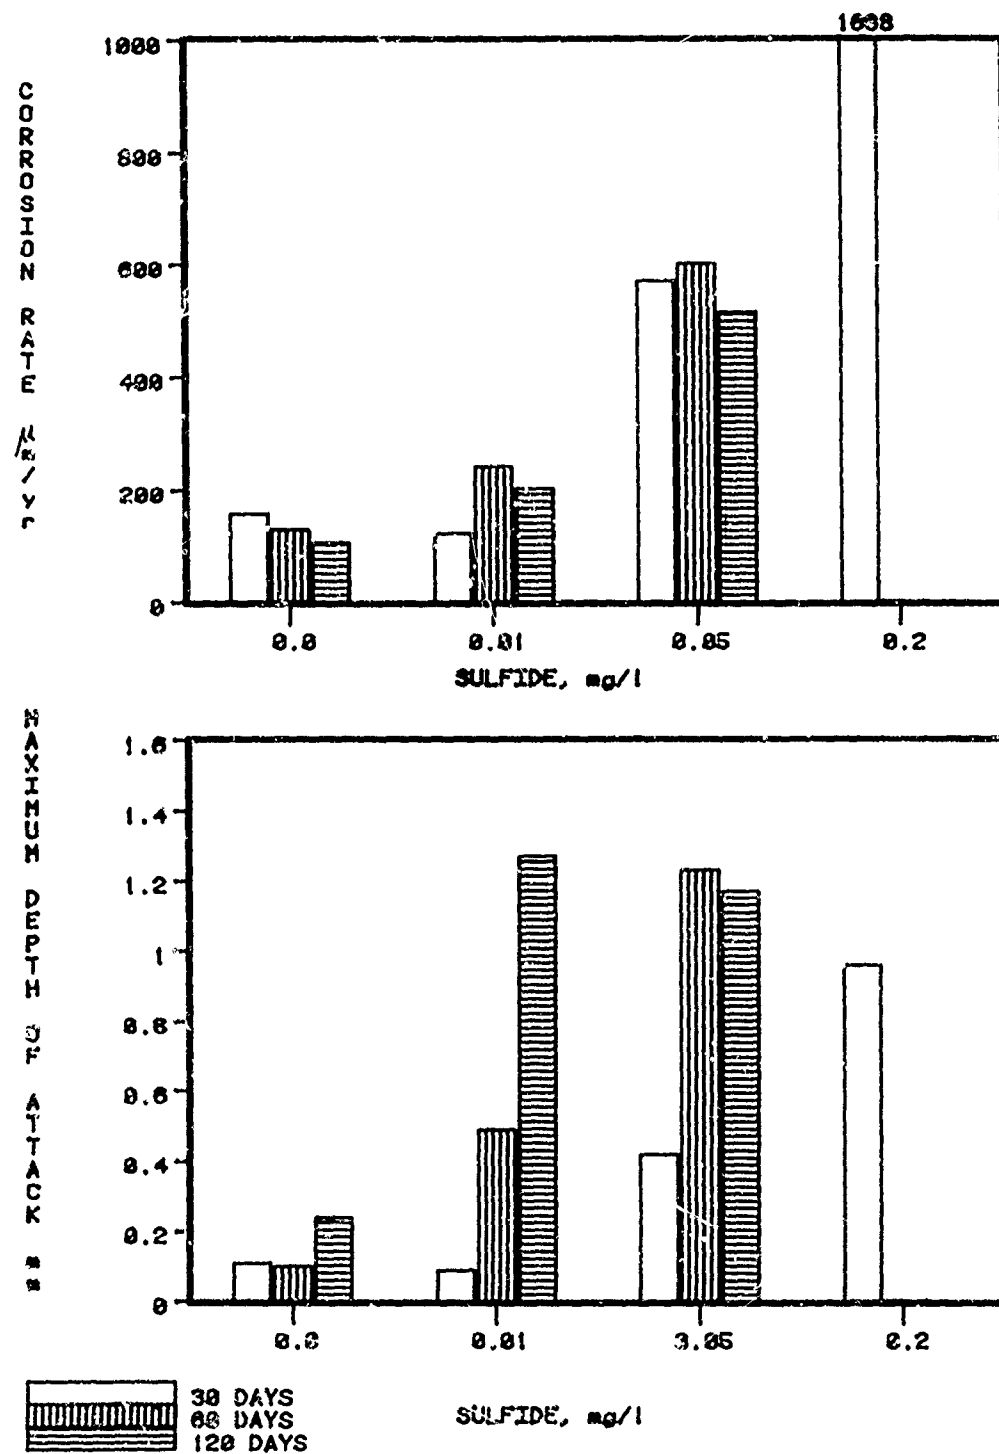
Figure 3. Corrosion of Wrought Ni-Al Bronze in Sulfide-Containing Seawater

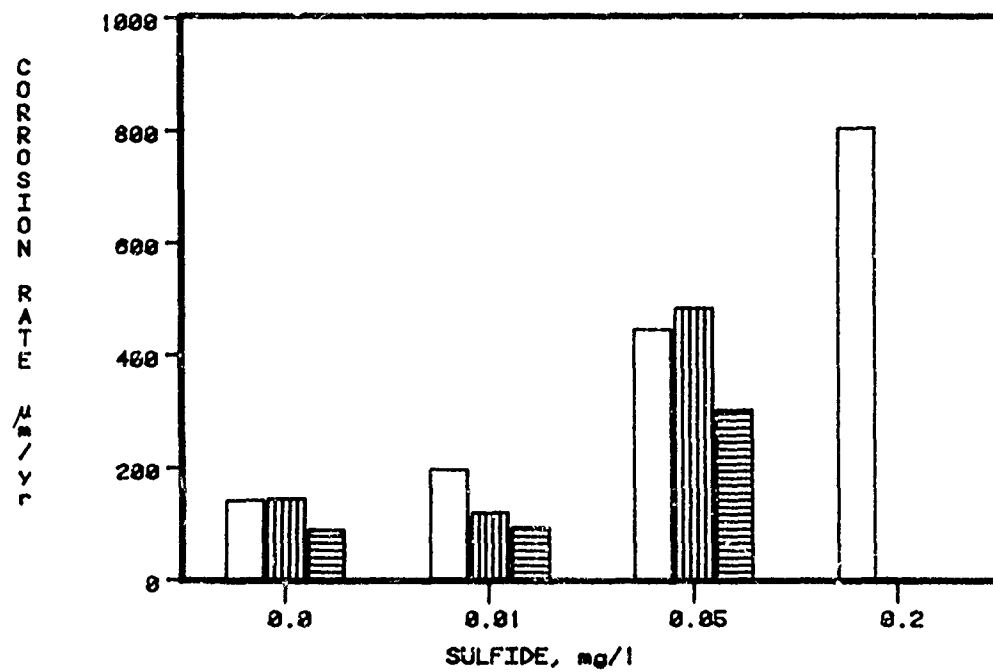
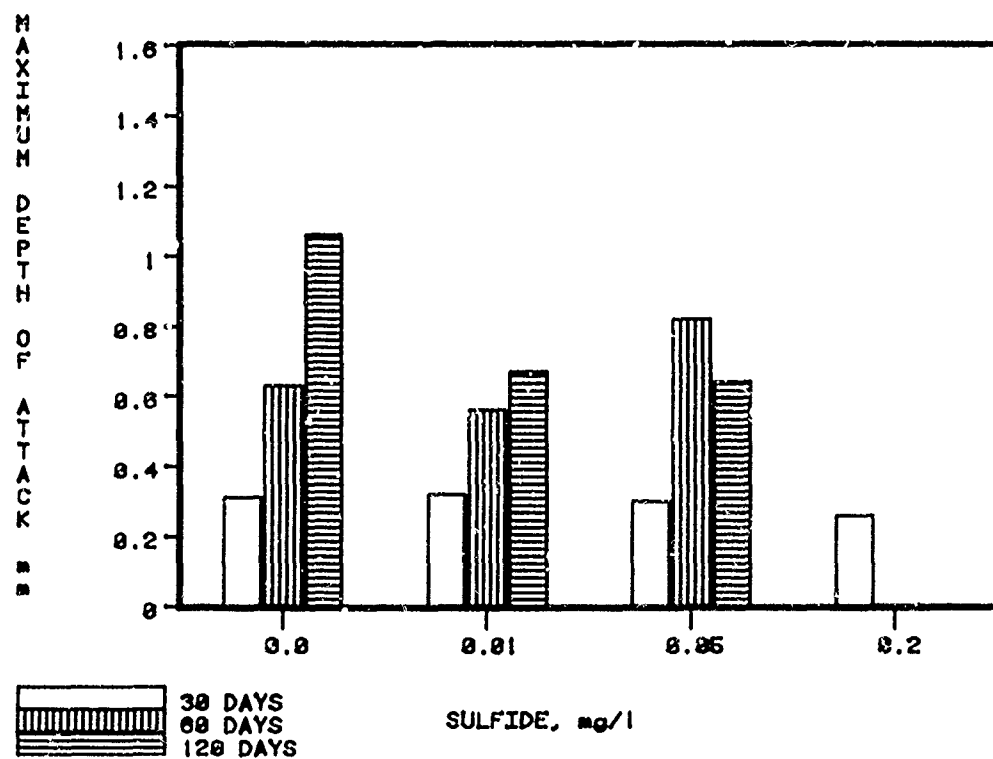
Figure 10. SME 79/56

MANGANESE BRONZE

Attack of the manganese bronze specimens, illustrated in Figures 9 and 10, is not affected by 0.01 mg/l sulfide. Corrosion rate increases are apparent at 0.05 mg/l sulfide, indicating greater general corrosion. Thus, alloy begins to exhibit sulfide corrosion susceptibility at the 0.05 mg/l level, and the attack remains general even at higher sulfide concentrations.

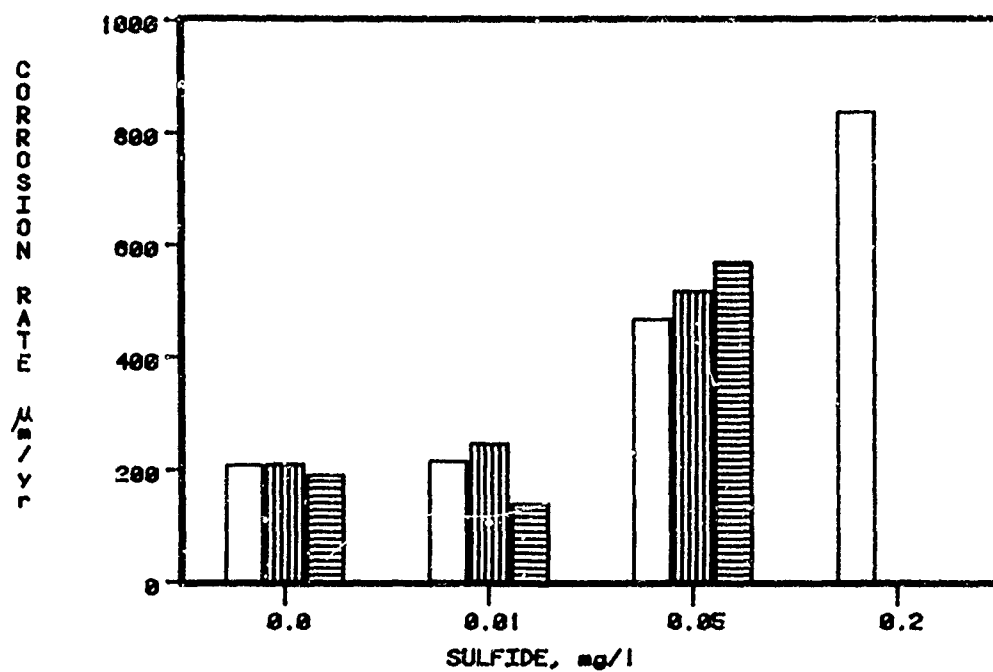
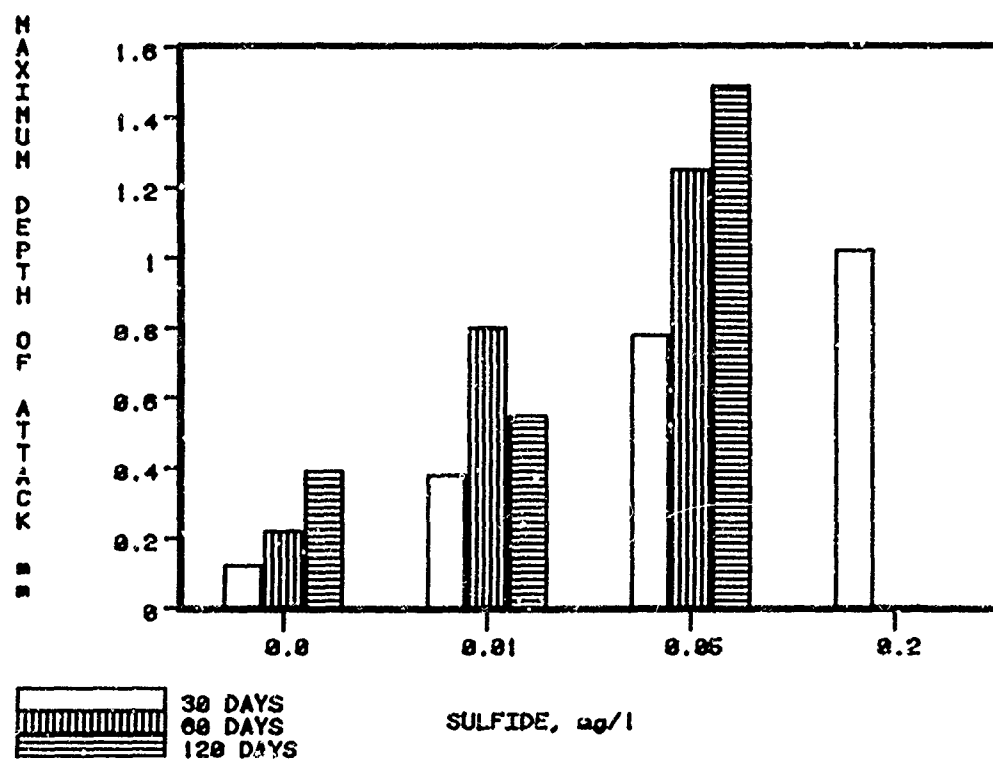
Figure 18. SME-79/56

70-30 COPPER-NICKEL

Adding about 6% tin to 90-10 copper nickel decreased slightly the depths of attack but otherwise did not significantly affect the alloy's performance in sulfide. This can be seen in Figures 17 and 18. The 70-30 copper-nickel performed similarly to 90-10 copper-nickel, except for generally slightly higher corrosion rates and depths of attack, as seen in Figure 19. Previous experiments with these alloys had shown greater corrosion of the 90-10 copper-nickel in sulfide-containing seawater.^{1,10,11} These differences may be due in part to temperature variations at the test site. The 70-30 copper-nickel also experienced localized corrosion at the crevices along the specimen edges created by the specimen holder, as seen in Figure 20. Thus, 70-30 copper-nickel experienced more corrosion and more localization of corrosion in these exposures than did 90-10 copper-nickel.

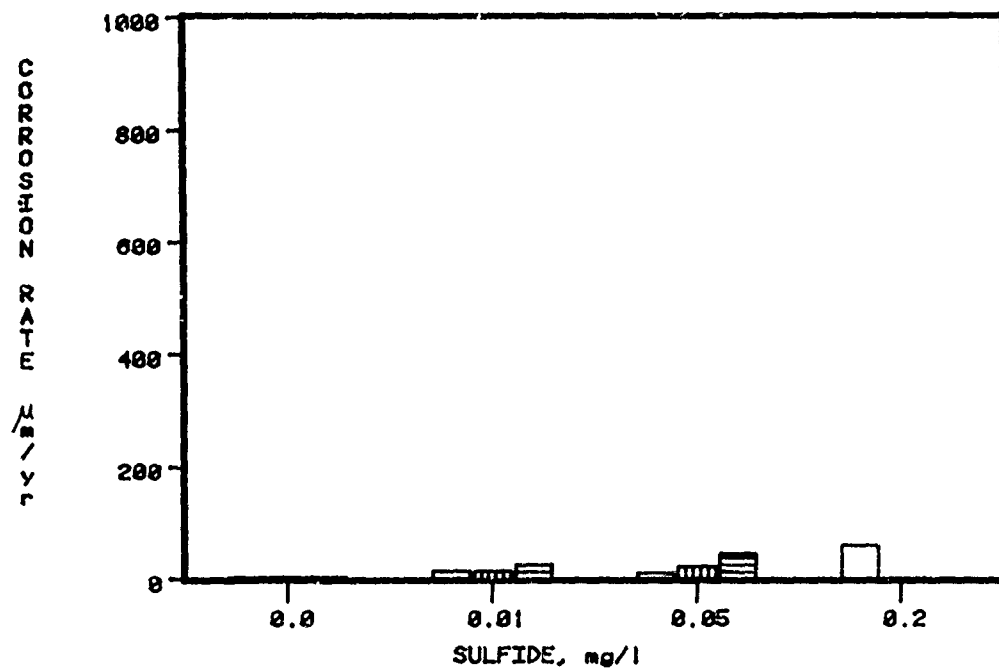
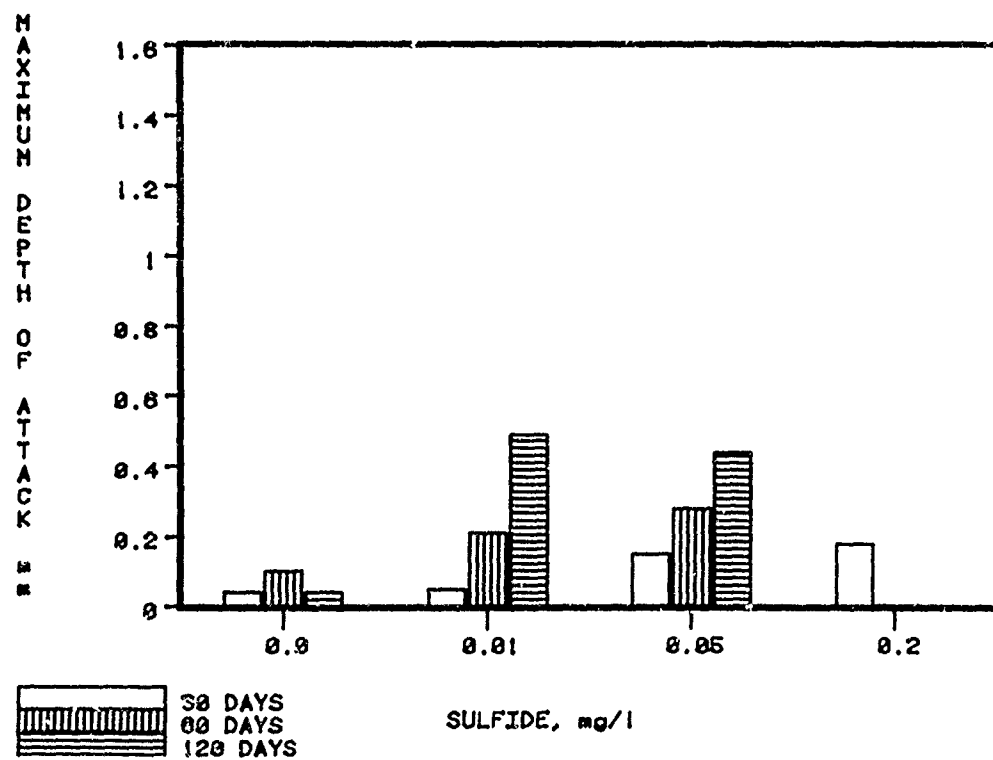
Figure 24. SME-79/56

WROUGHT NICKEL-COPPER

Corrosion of wrought nickel-copper was lower than most alloys in the test. As seen in Figure 23, the corrosion rates and maximum depths of attack increased with increasing sulfide concentration or duration. The effect was noticeable even in the 30-day, 0.01-mg/l sulfide exposure. Corrosion tended to take the form of pitting, as seen in Figure 24. Although the amount of corrosion of this alloy was low, the factor of increase in corrosion of specimens exposed to sulfide over the controls was large.

Although the corrosion rate of cast nickel-copper without sulfide was similar to its wrought analog (Figure 25), and the maximum depth of attack was slightly greater than wrought material, behavior of cast material in sulfide was much different than that of the wrought alloy. Corrosion rates and depths of attack of cast material in sulfide were several orders of magnitude greater than those for wrought material. Thus, cast nickel-copper was the material most susceptible to sulfide attack in these tests, on the basis of its factor of increase in corrosion over control specimens. Generally, attack took the form of uniform etching, as seen in Figure 26. A comparison of Figure 26 with Figure 24 shows the difference in behavior of cast and wrought material.

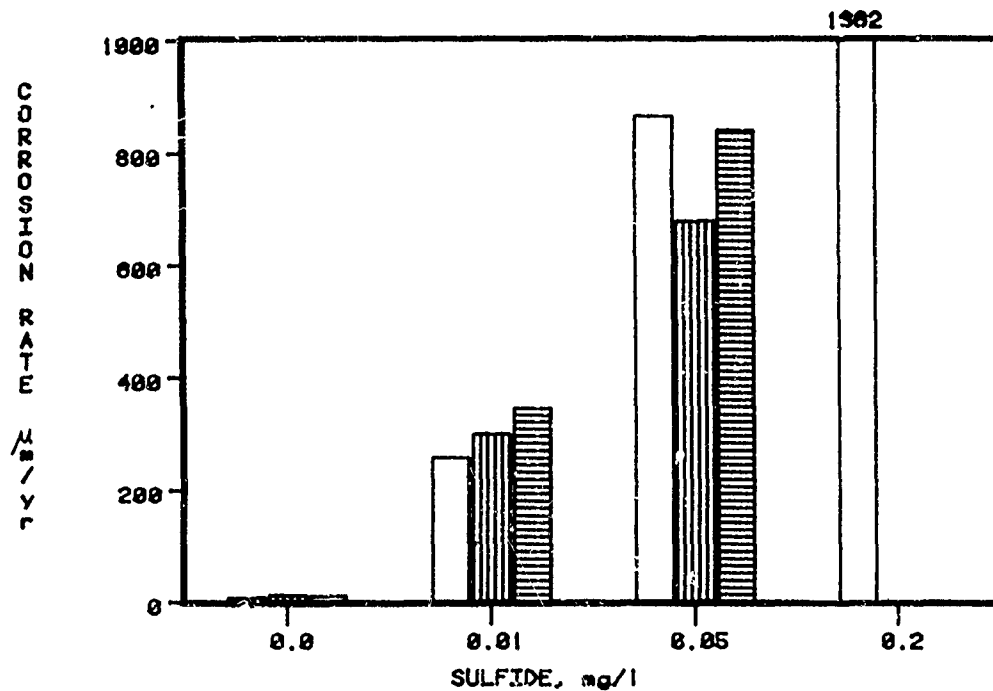
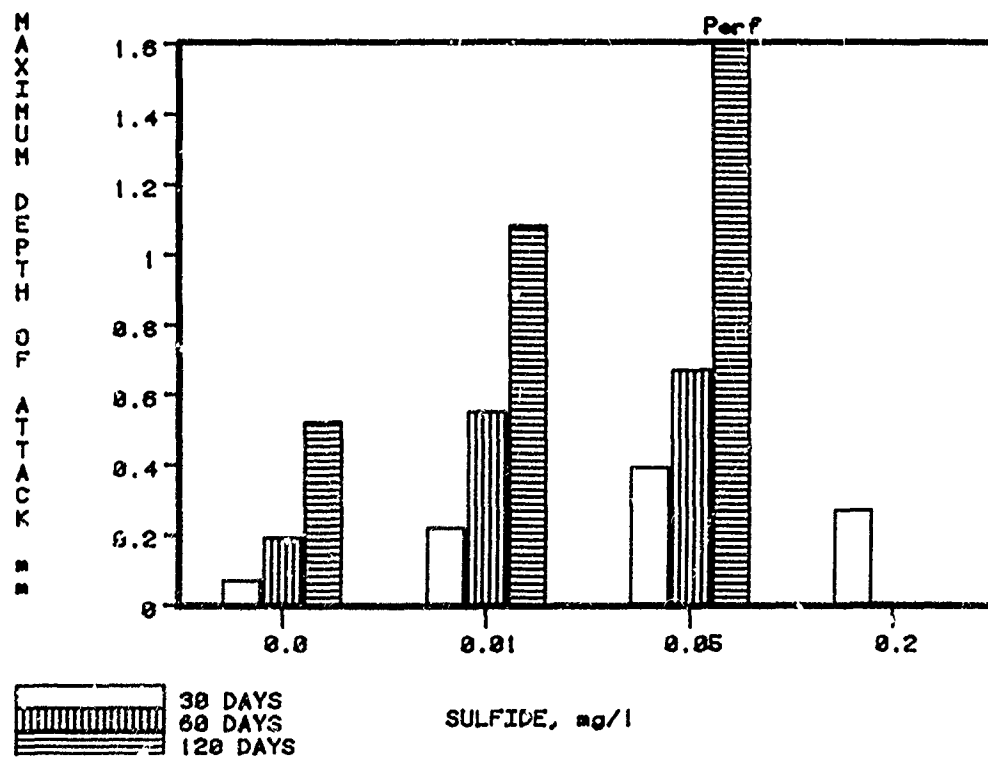
Figure 26. SME 79/56

CAST NICKEL-COPPER

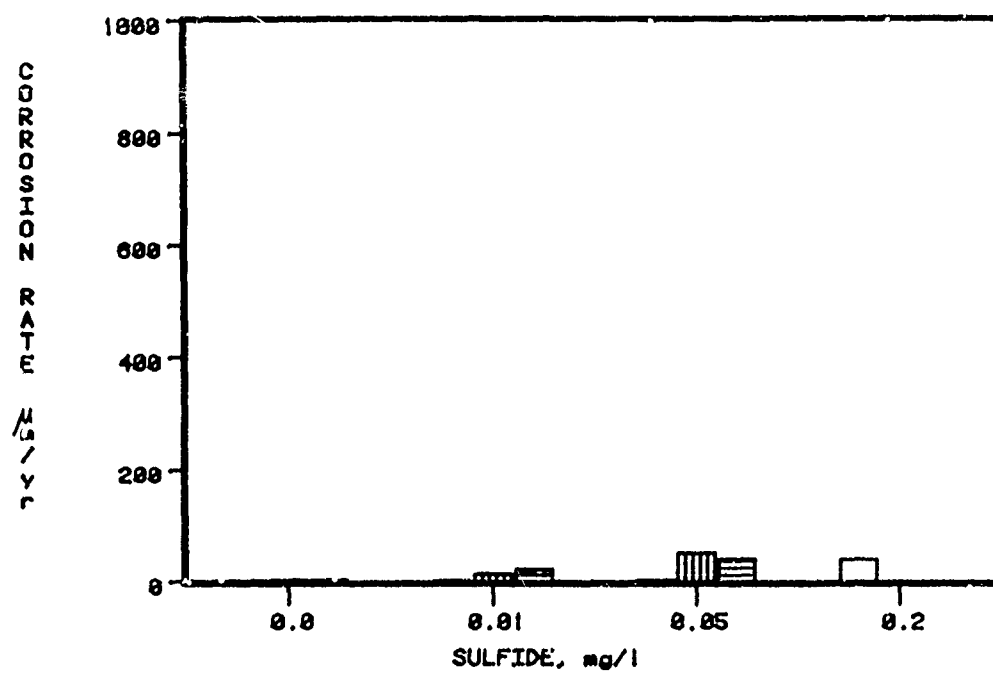
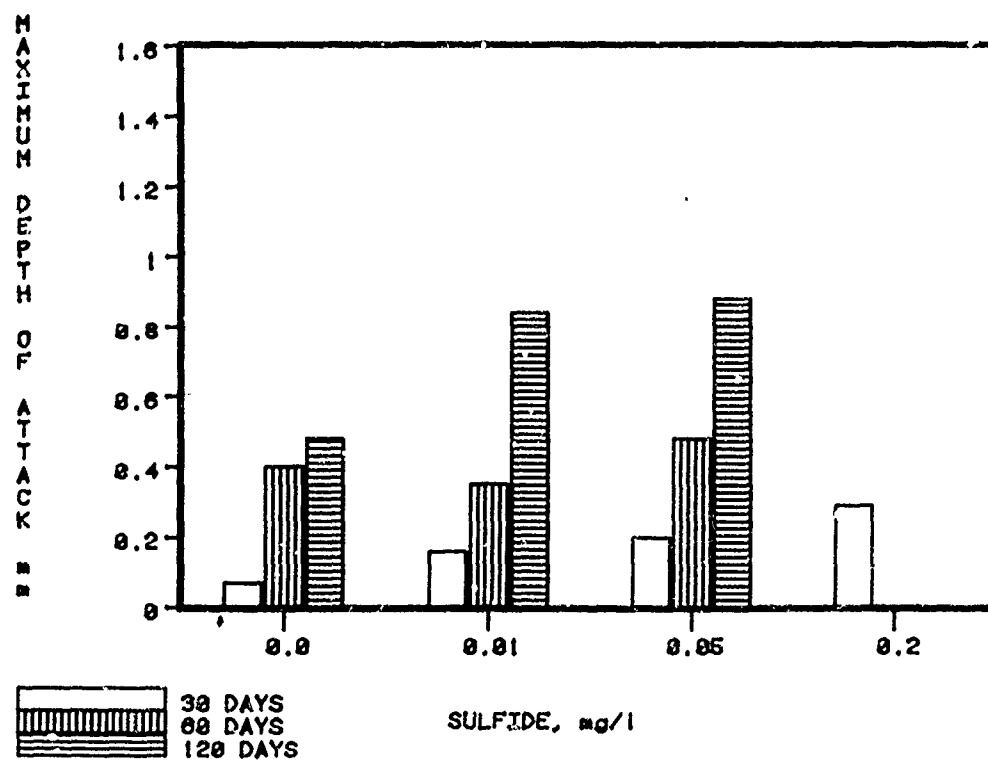
Figure 28. SME 79/56

NICKEL-COPPER K-500

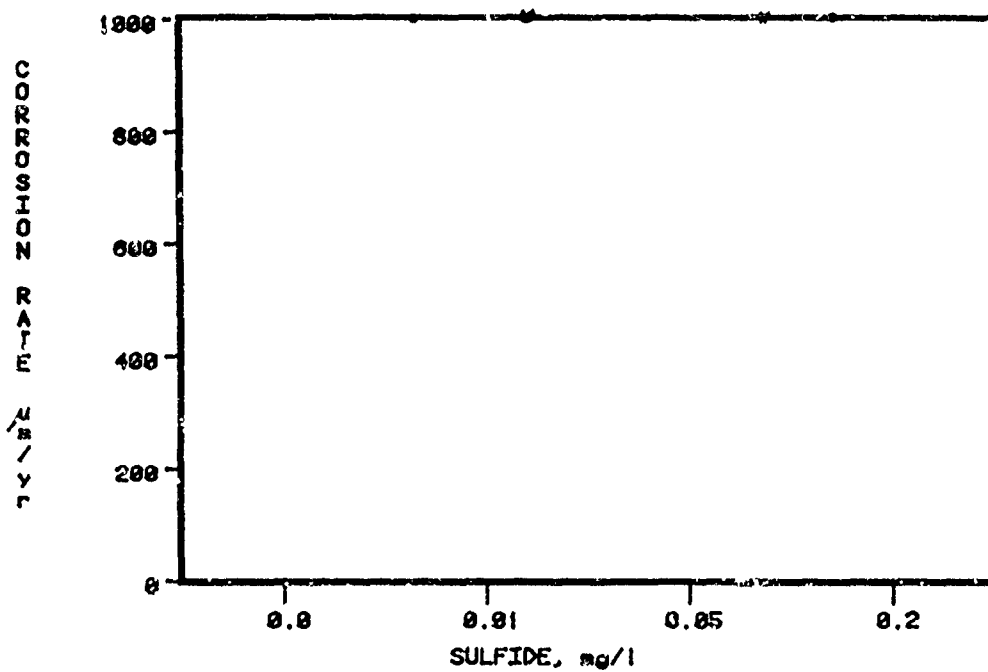
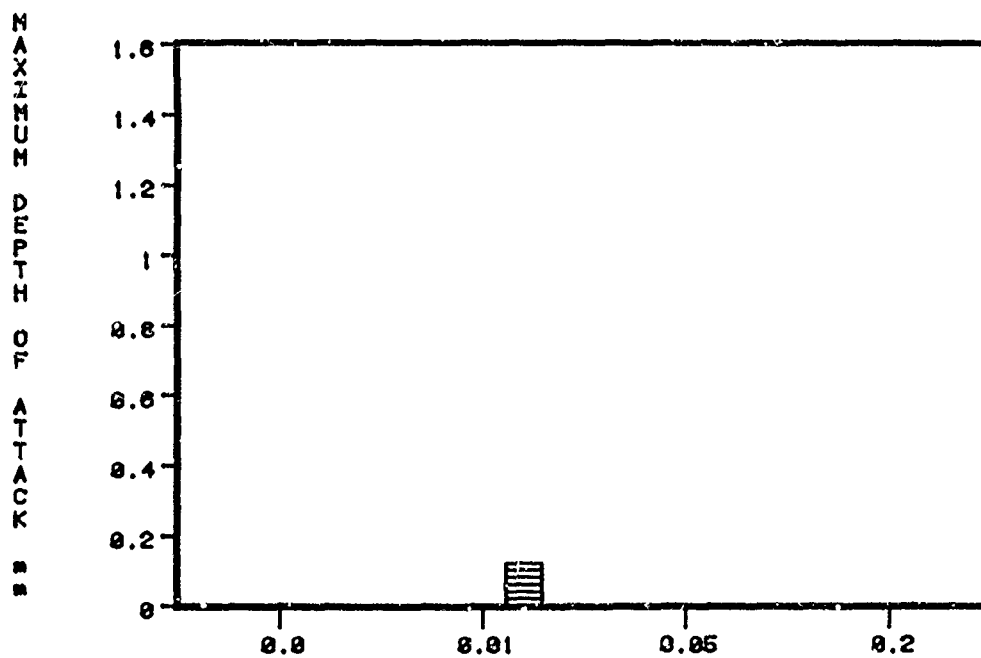
Figure 30. SME 79/56

316 STAINLESS STEEL

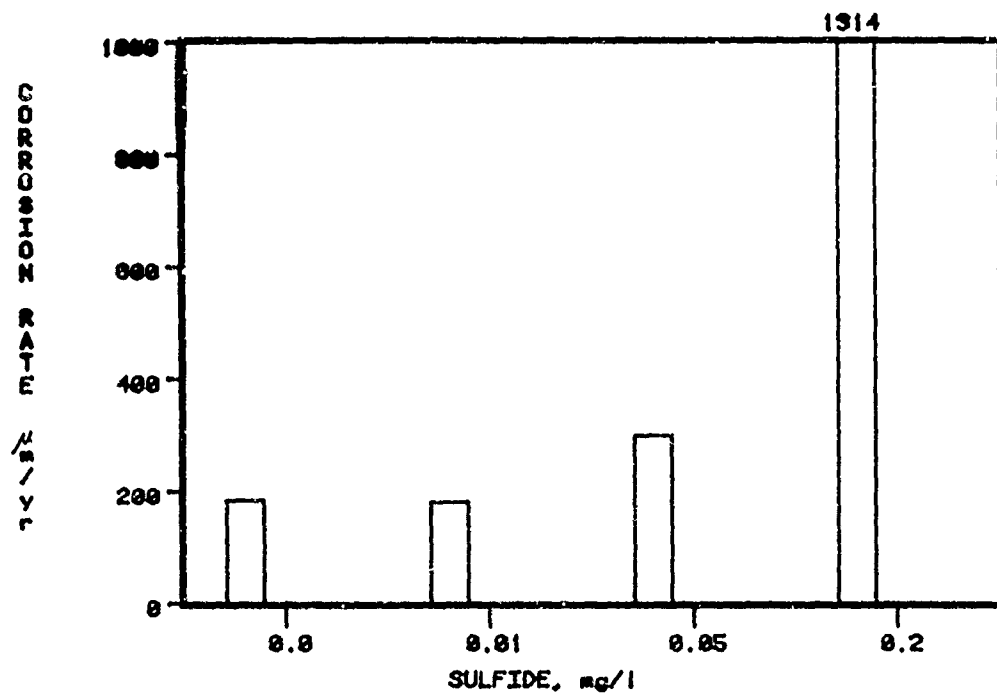
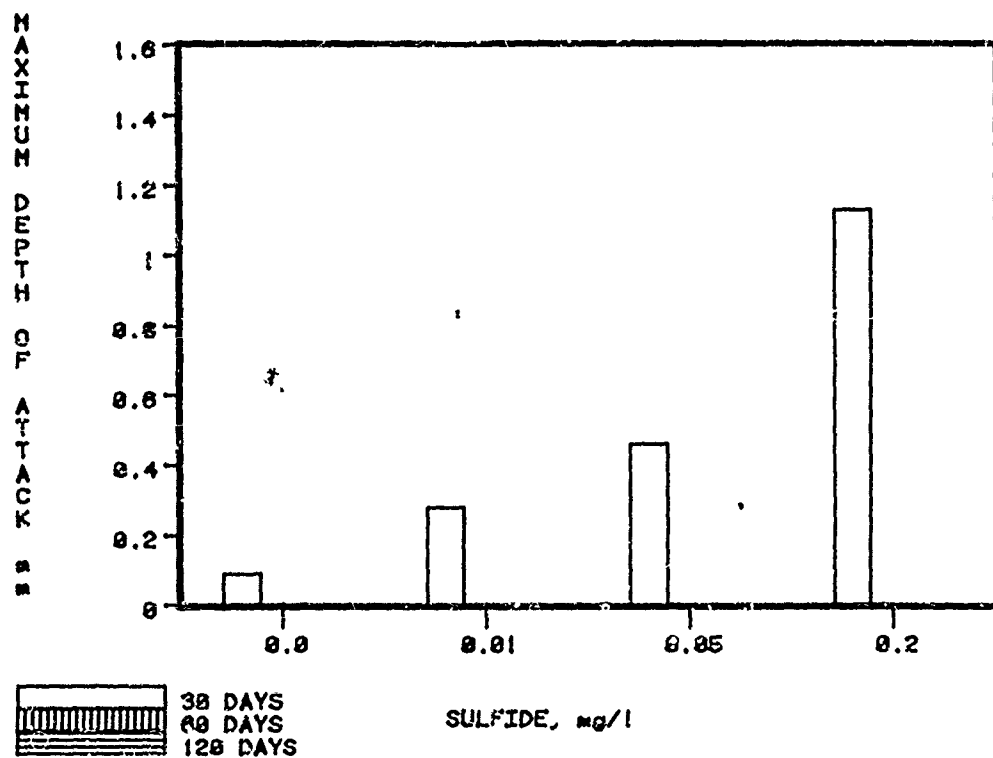
Figure 32. SME 79/56

ALUMINUM BRONZE D

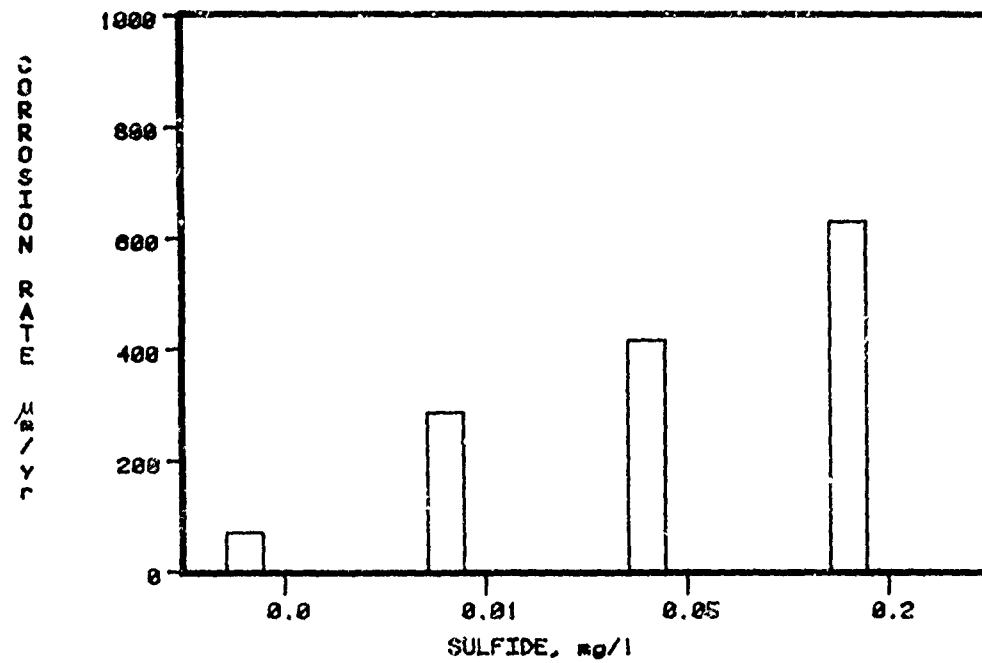
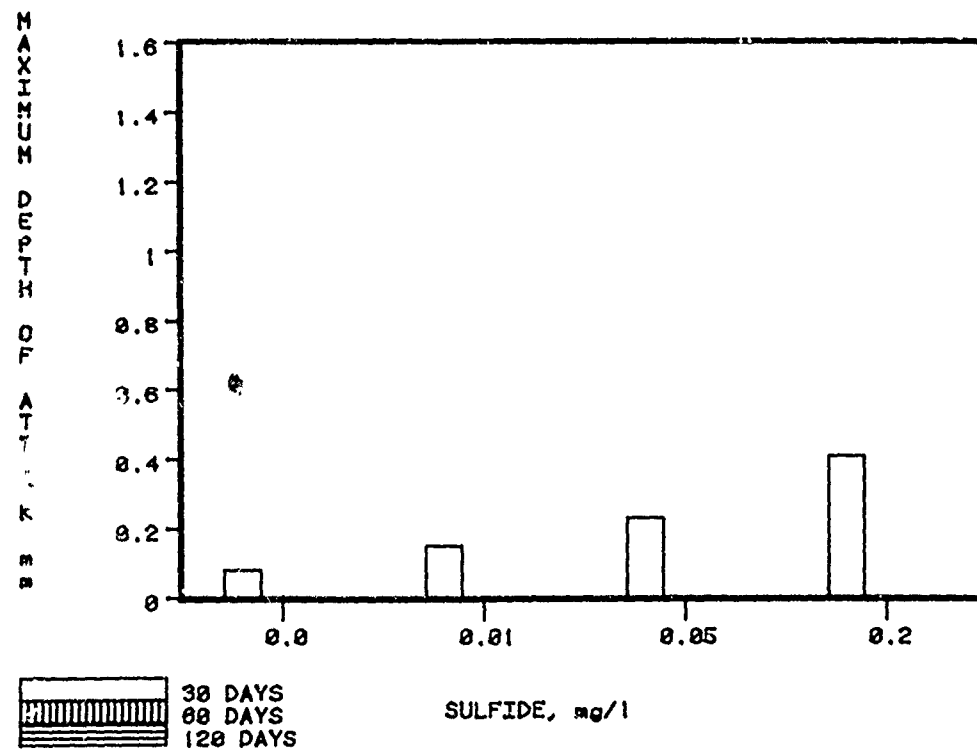
Figure 34. SME 79/56

PHOSPHOR BRONZE + 5% TIN

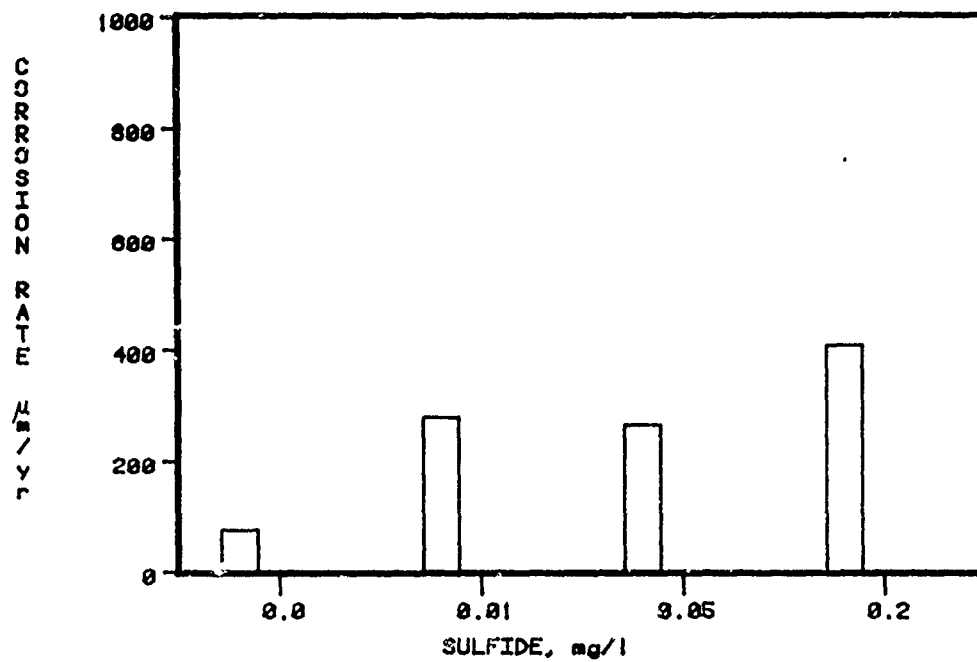
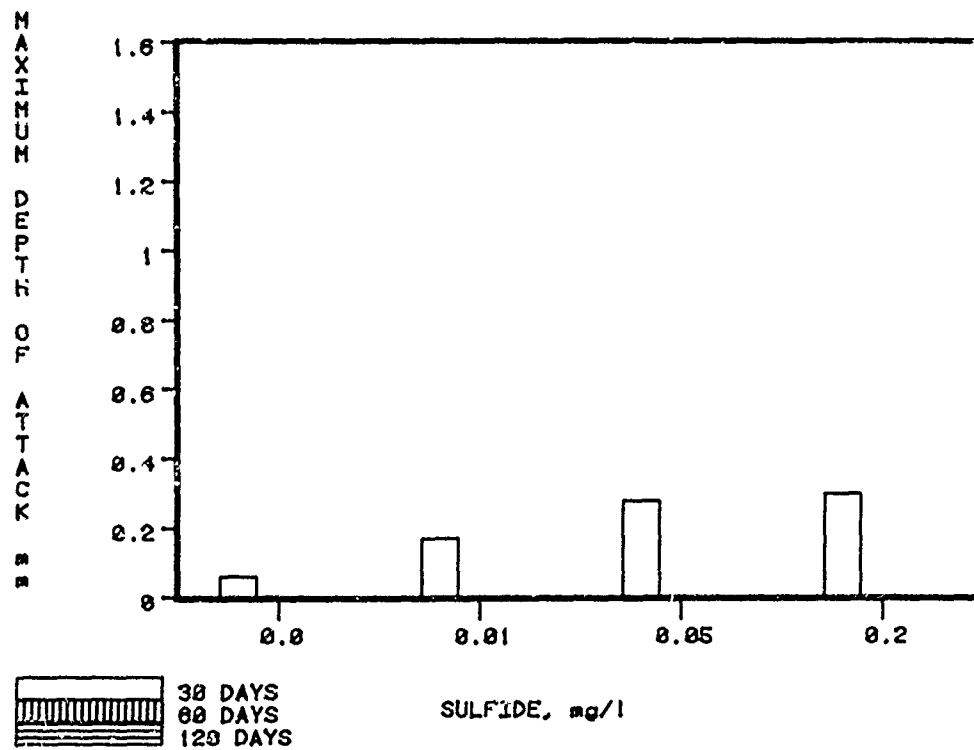
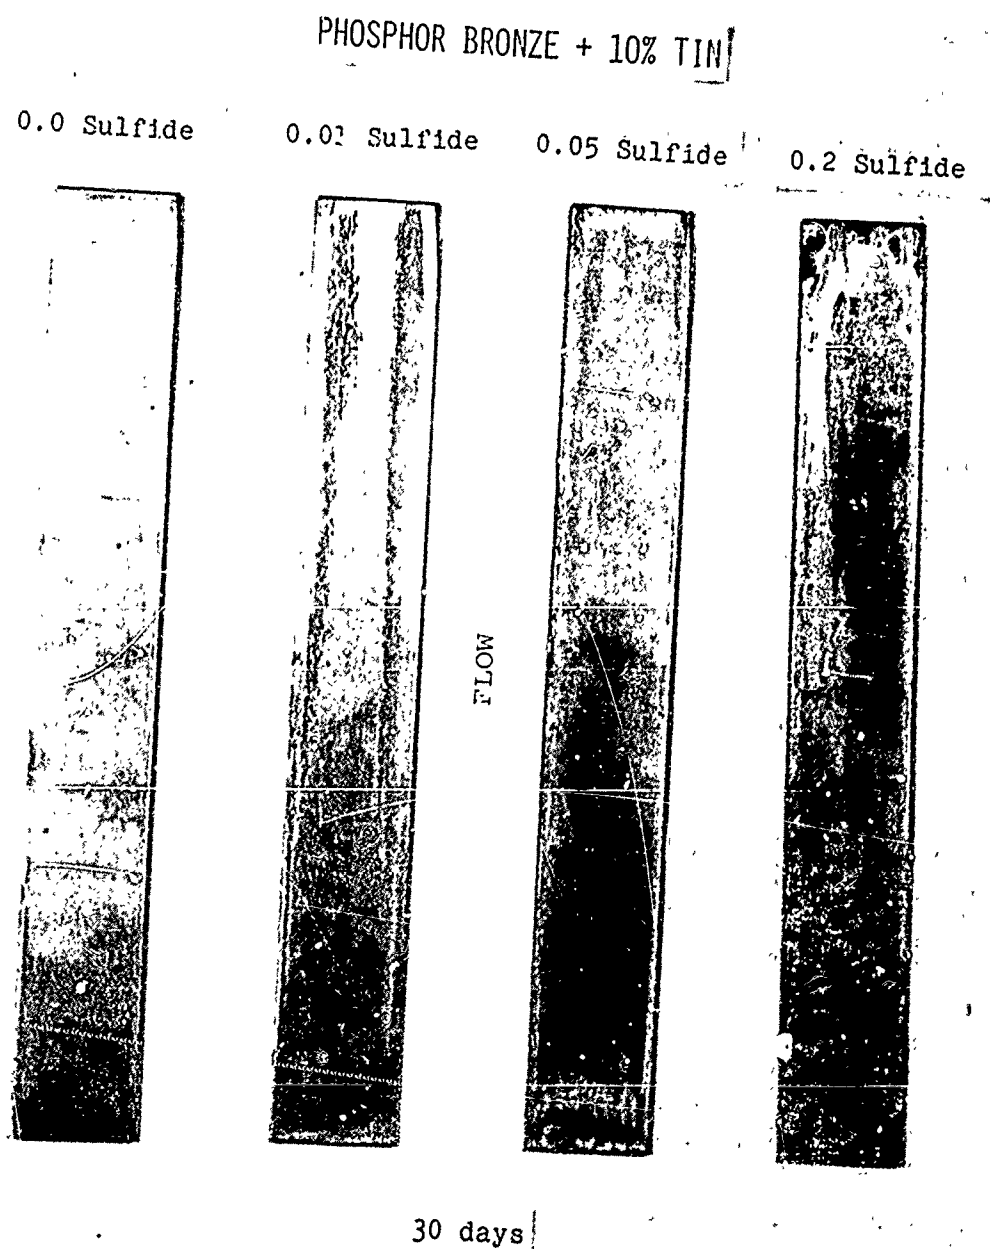
Figure 36. SME 79/56

PHOSPHOR BRONZE + 10% TIN

Results of exposures of phosphor bronze with 10% tin (presented in Figures 36 and 36) indicate similar behavior to the 5% tin alloy. Thus, the additional 5% tin had little effect on the corrosion behavior of the phosphor bronze.
